## **Vegetation and Channel Morphology Responses to Ordinary High Water Discharge Events in Arid West Stream Channels**

Robert Lichvar, David Cate, Corinna Photos,  
Lindsey Dixon, Bruce Allen, and Joel Byersdorfer

May 2009

*Cold Regions Research and Engineering Laboratory  
U.S. Army Engineer Research and Development Center  
72 Lyme Road  
Hanover, NH 03755-1290*

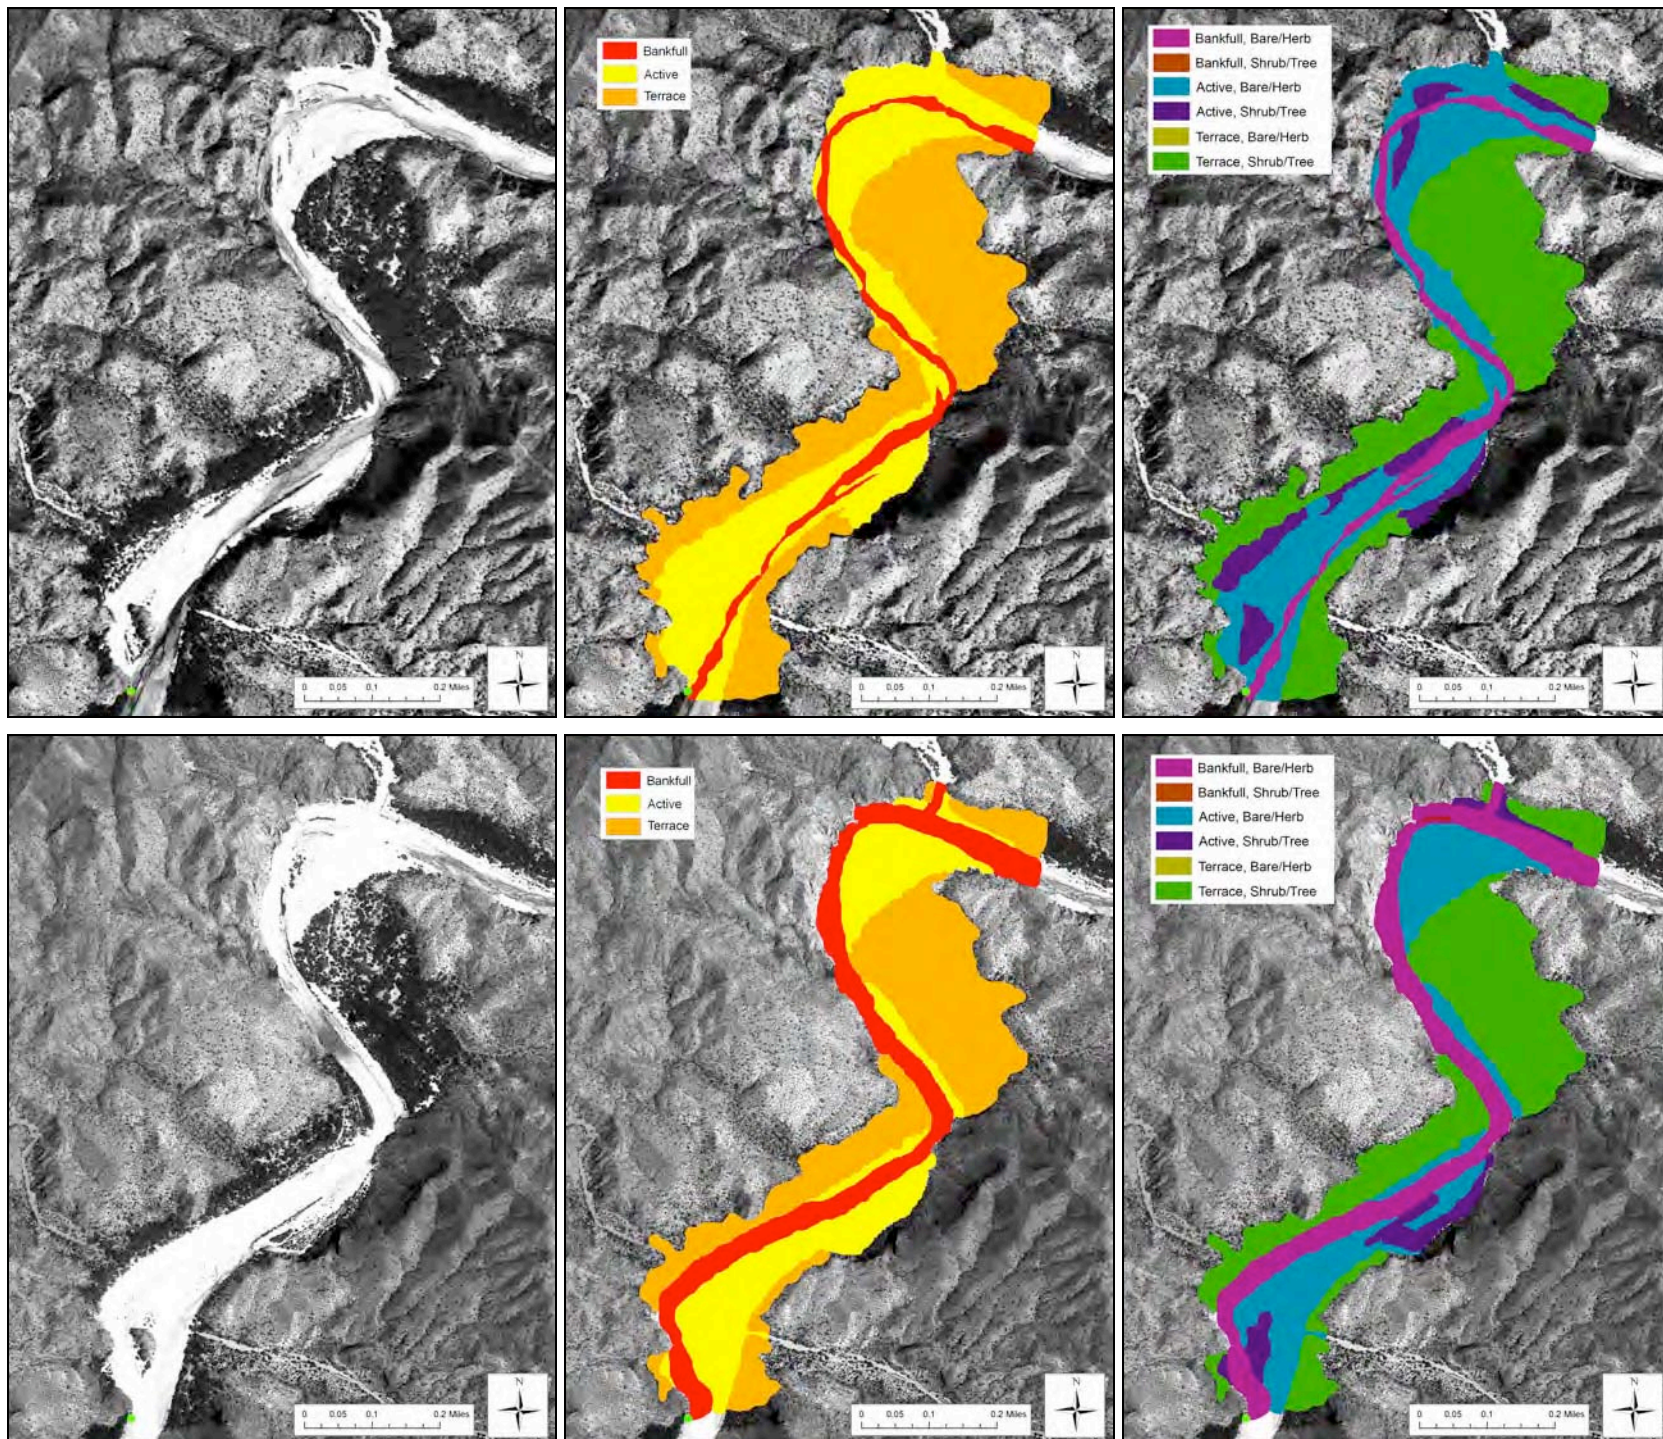
Figure C7. Santa Maria River in 1992 (top three) and 1997 (bottom three) showing the change in channel morphology and vegetation.

1992		1997	
	Area (m <sup>2</sup> )	% of Total	Area (m <sup>2</sup> )	% of Total
Bankfull	49,591	9.4	116,811	23.8
Active	222,002	41.9	150,773	30.7
Terrace	257,963	48.7	223,503	45.5
Total	529,556	100	491,087	100
Bankfull-Bare/Herb	49,591	9.4	116,233	23.7
Bankfull-Shrub/Tree	0	0	578	0.1
Active-Bare/Herb	171,218	32.3	122,274	24.9
Active-Shrub/Tree	50,784	9.6	28,499	5.8
Terrace-Bare/Herb	0	0	0	0
Terrace-Shrub/Tree	257,963	48.7	223,503	45.5
Total	529,556	100	491,087	100

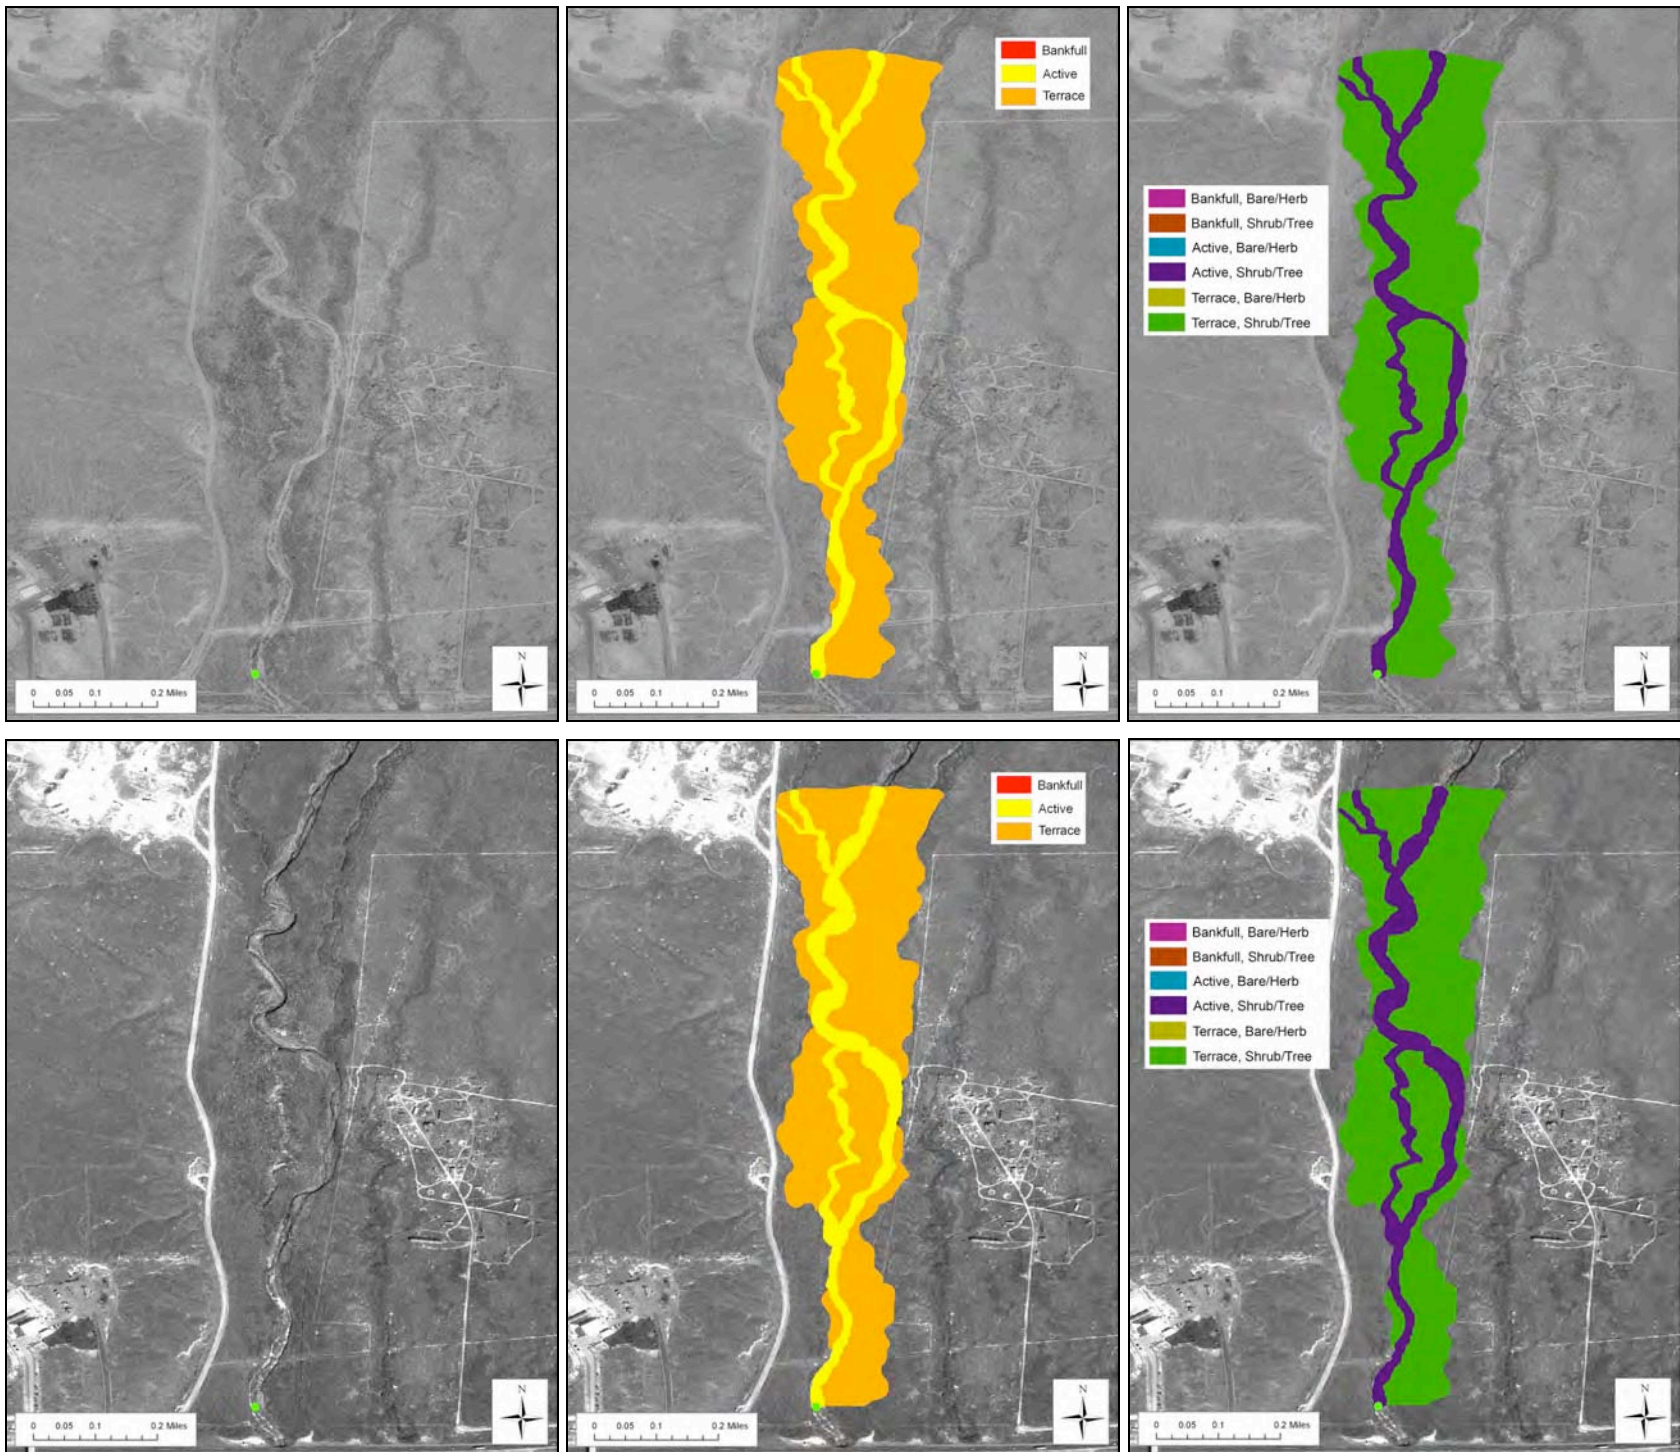
Figure C8. Susie Creek in 1994 (top three) and 1999 (bottom three) showing the change in channel morphology and vegetation.

1994		1999	
	Area (m <sup>2</sup> )	% of Total	Area (m <sup>2</sup> )	% of Total
Bankfull	0	0	0	0
Active	60,627	19.1	69,927	22.3
Terrace	256,129	80.7	243,011	77.6
Total	316,756	99.8	312,938	99.9
Bankfull-Bare/Herb	0	0	0	0
Bankfull-Shrub/Tree	0	0	0	0
Active-Bare/Herb	0	0	0	0
Active-Shrub/Tree	60,627	19.1	69,927	22.3
Terrace-Bare/Herb	0	0	0	0
Terrace-Shrub/Tree	256,129	80.7	243,011	77.6
Total	316,756	99.8	312,938	99.9

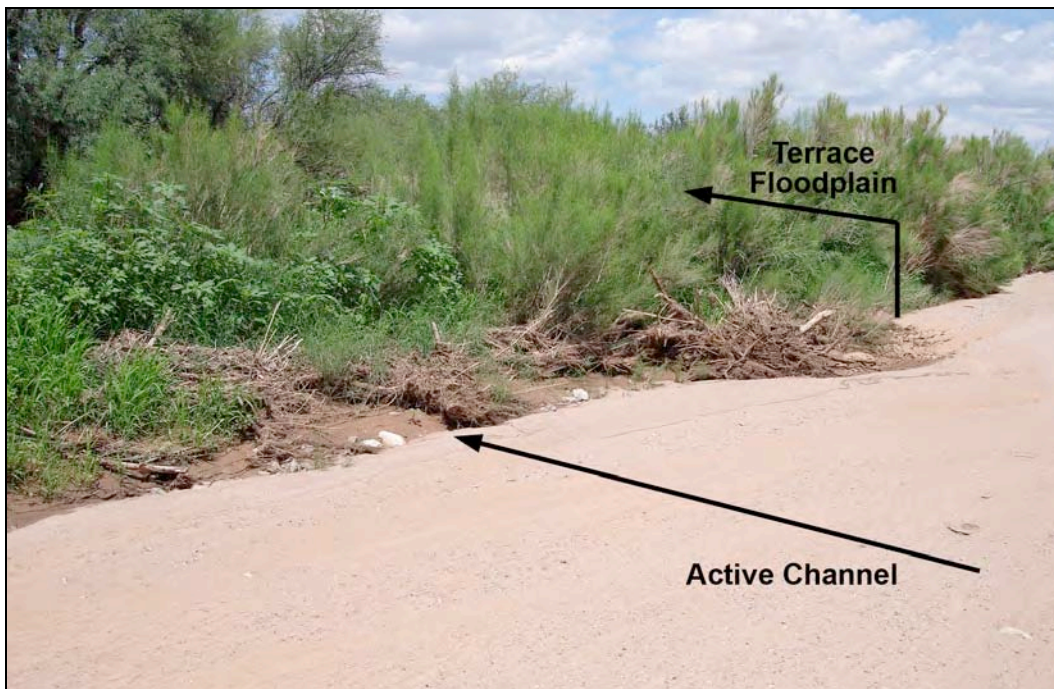
Figure E2. Drift at boundary of active channel, Altar Wash.

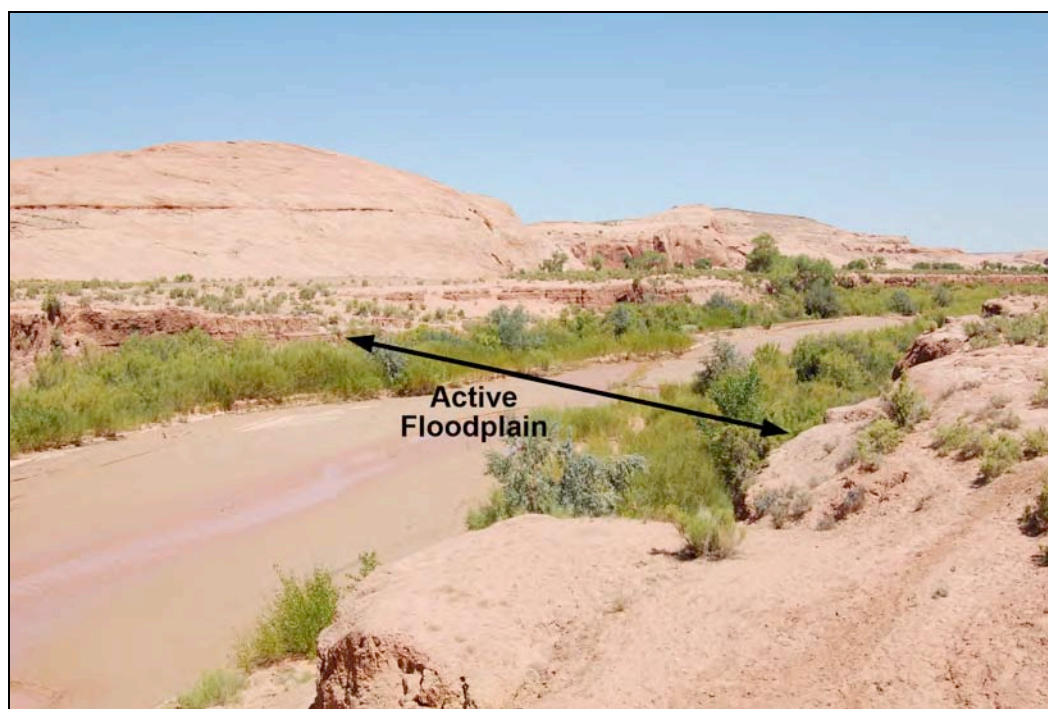
Figure E4. Active floodplain at Chinle Creek.

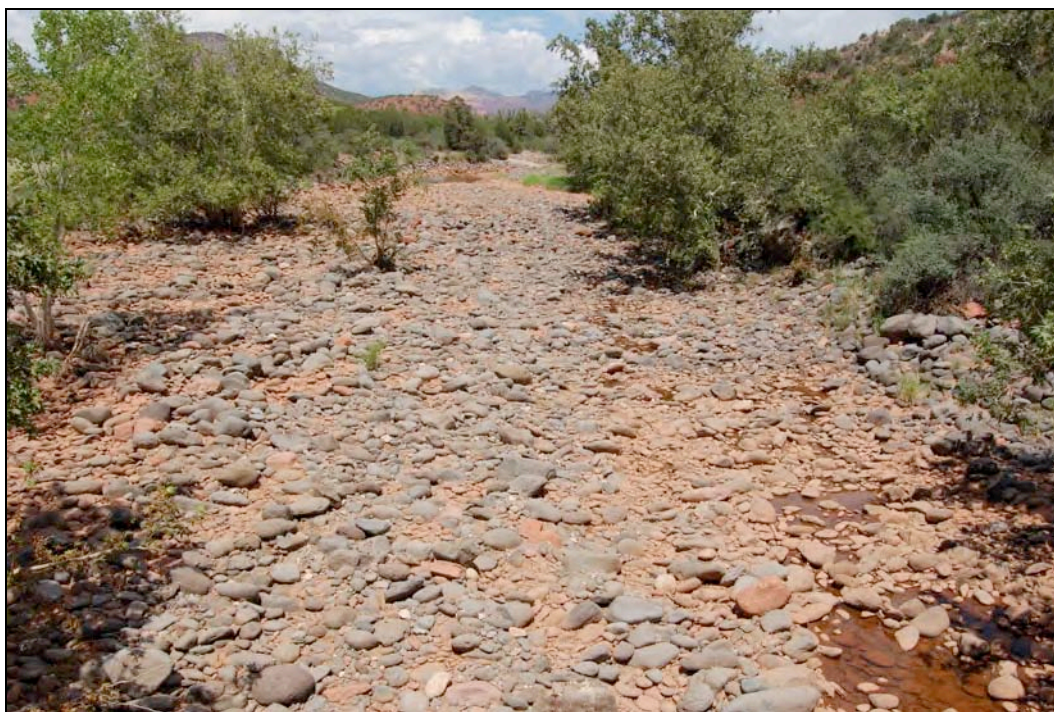
Figure E5. Active floodplain at Dry Beaver Creek.

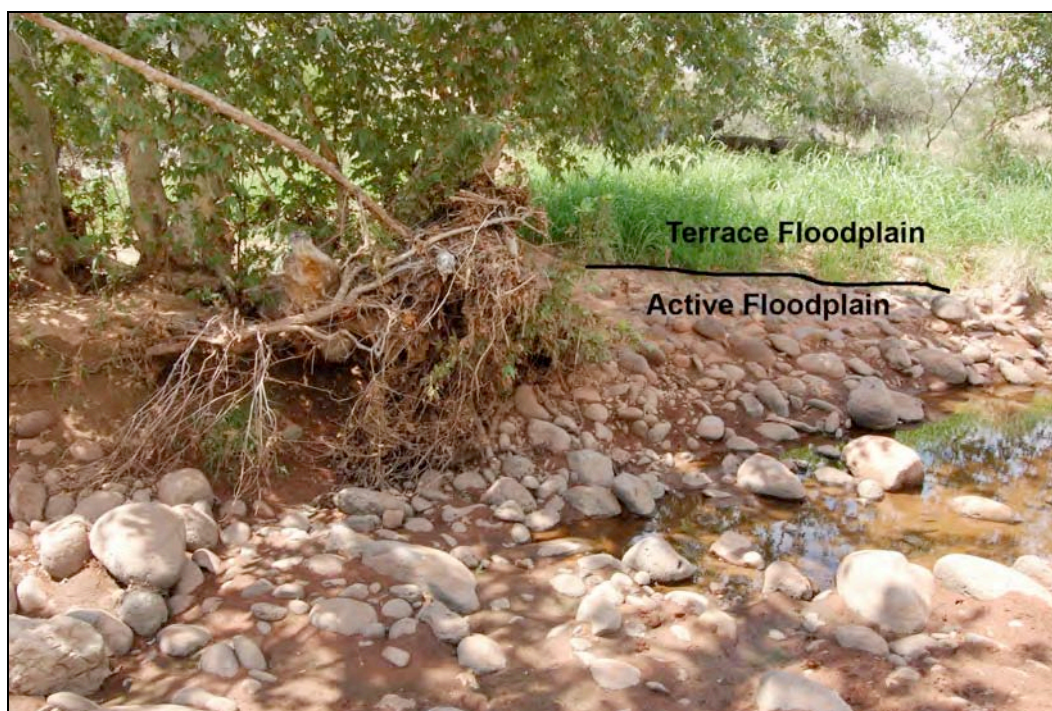
Figure E6. Boundary between the terrace floodplain and the active floodplain at Dry Beaver Creek.

The active/terrace interface margins were much more stable than the bankfull margins. Regardless of the size of the discharge event, the boundaries between the active and terrace zones remained relatively stable. (An exception is the Cristianitos site, where there's no bankfull channel and the active/terrace boundary changed in places, although the relative areas didn't change much.) Appendix E contains ground photos showing active/terrace boundaries at several sites.

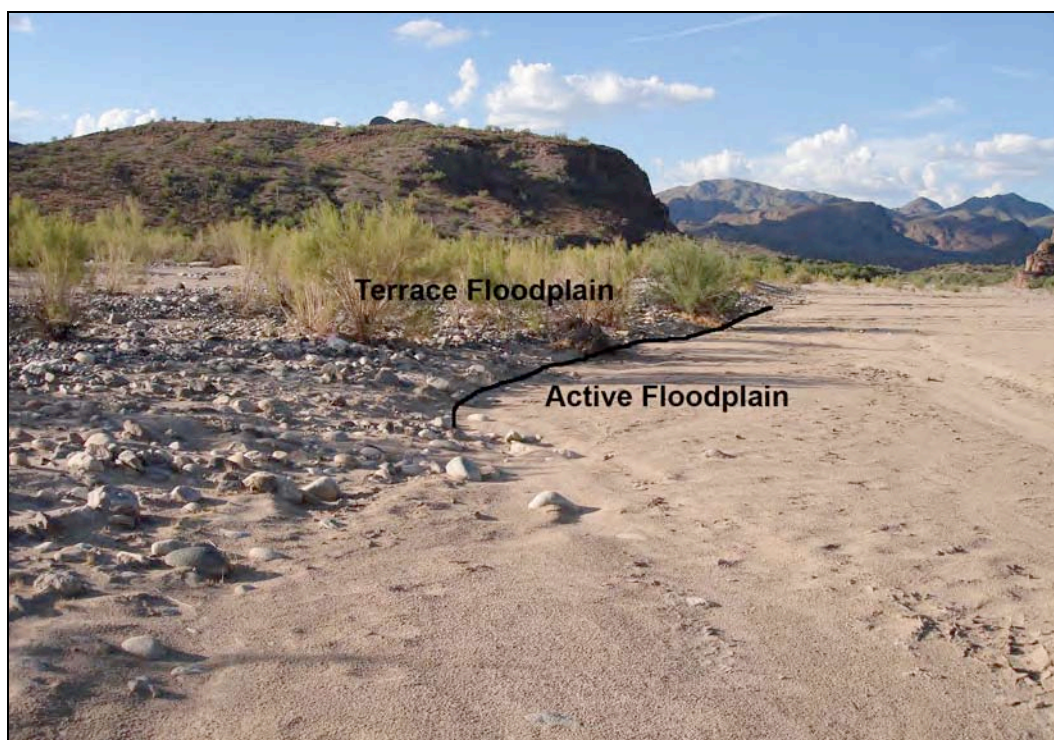
Figure E7. Boundary between the terrace floodplain and the active floodplain at Santa Maria Creek.

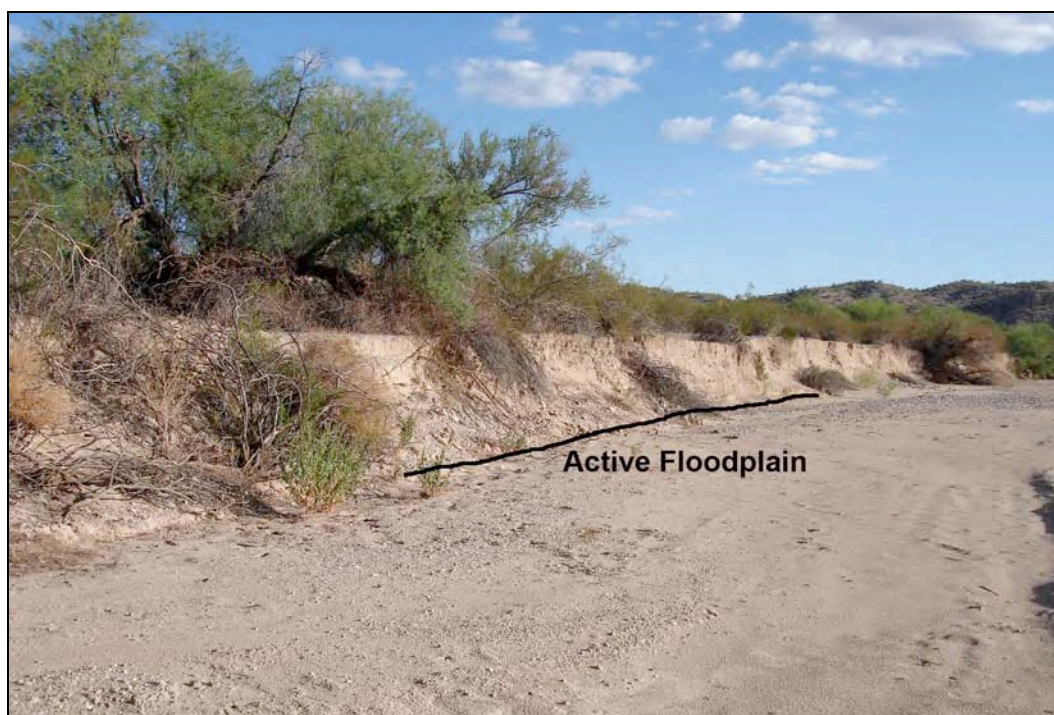
Figure E8. Active floodplain at Santa Maria Creek.

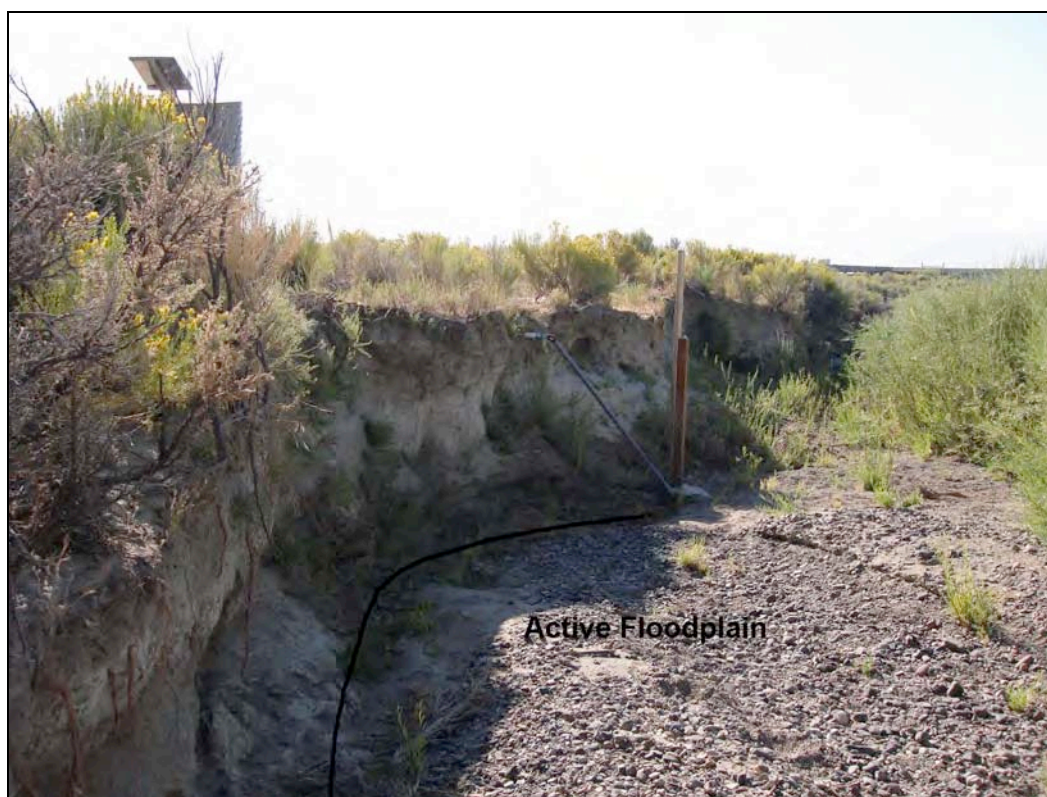
Figure E9. Active floodplain at the Susie Creek gauge.

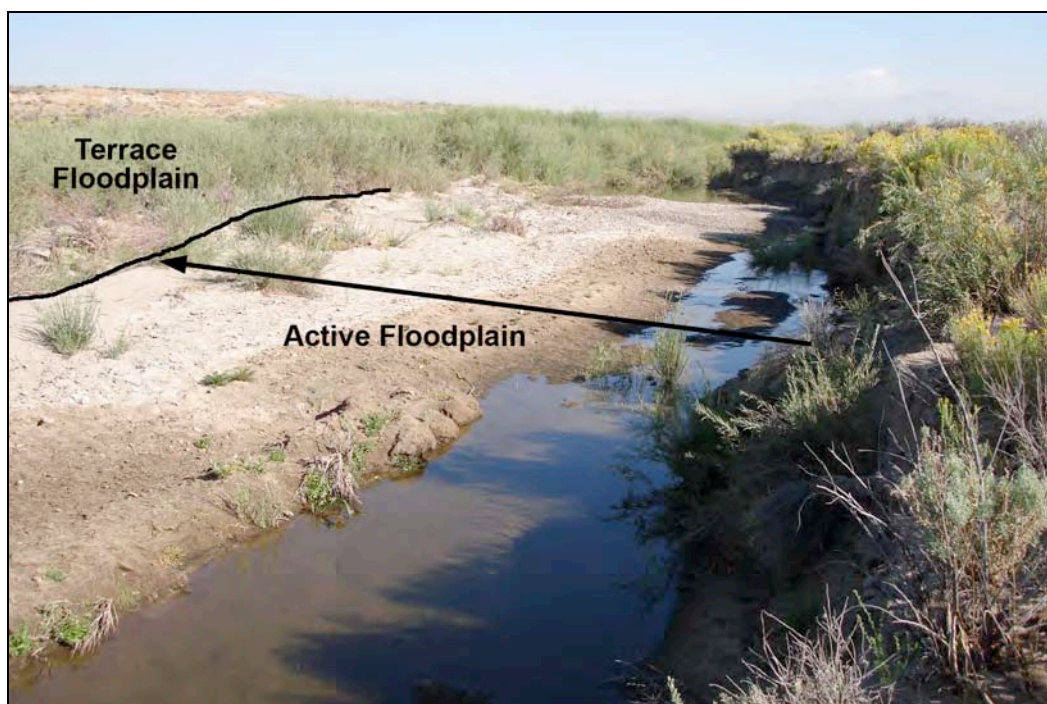
Figure E10. Boundary between the terrace floodplain and the active floodplain at Susie Creek.
